**Barrier Delineators:**  
*Field Performance Study and Research  
Findings of Alternative Barrier  
Delineators*

## UDOT RESEARCH & DEVELOPMENT REPORT ABSTRACT

This test section is spread out over six miles. The section starts at approximately mile marker 114 on eastbound I-80 by the Salt Lake International airport. Barrier delineators were installed in July 1996 on the all of the concrete barriers and bridge parapets on the right side of the roadway. Six different brands of top-mounting barrier delineators were tested. Approximately thirty replicates of each were tested. An intermediate evaluation was performed in December of 1996, halfway through the '96/'97 winter season. It was found that the galvanized steel delineators were not holding up as well as the other products. The final performance evaluation was made during mid-June of 1997. These barrier delineators will be left out in the field to make it possible to make future evaluations.

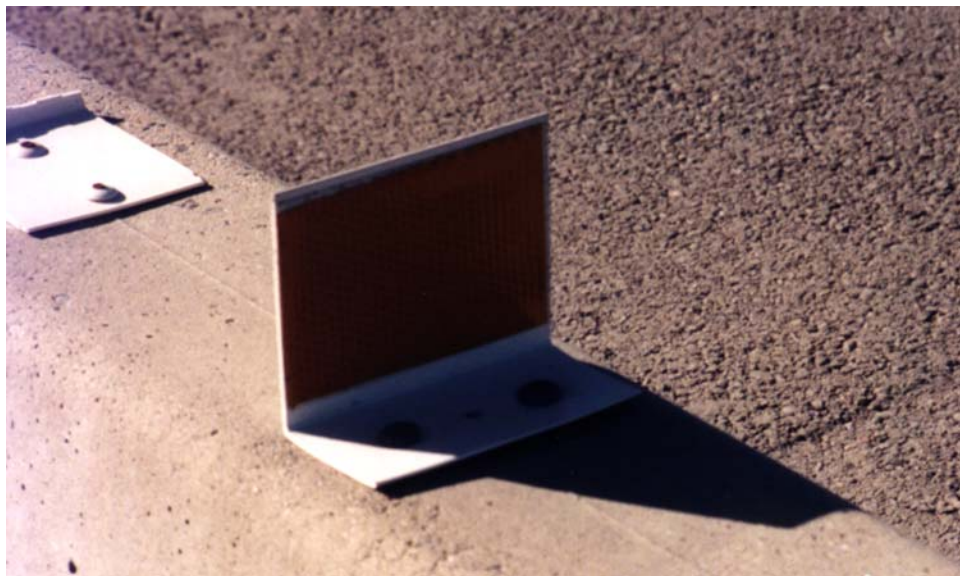
**PCBM-12**

This is a shorter version of the current barrier delineator now in use. It is manufactured by Davidson Plastics. The product is a white L-shaped plastic bracket which has a reflector size that is 4.25"x3". This product had a install time of forty-five seconds and was anchored with two 1" steel anchors. The cost of the product is a \$1.45 each.

Thirty-nine of these were installed starting at mile post 114.5. A picture of the PCBM is shown below.

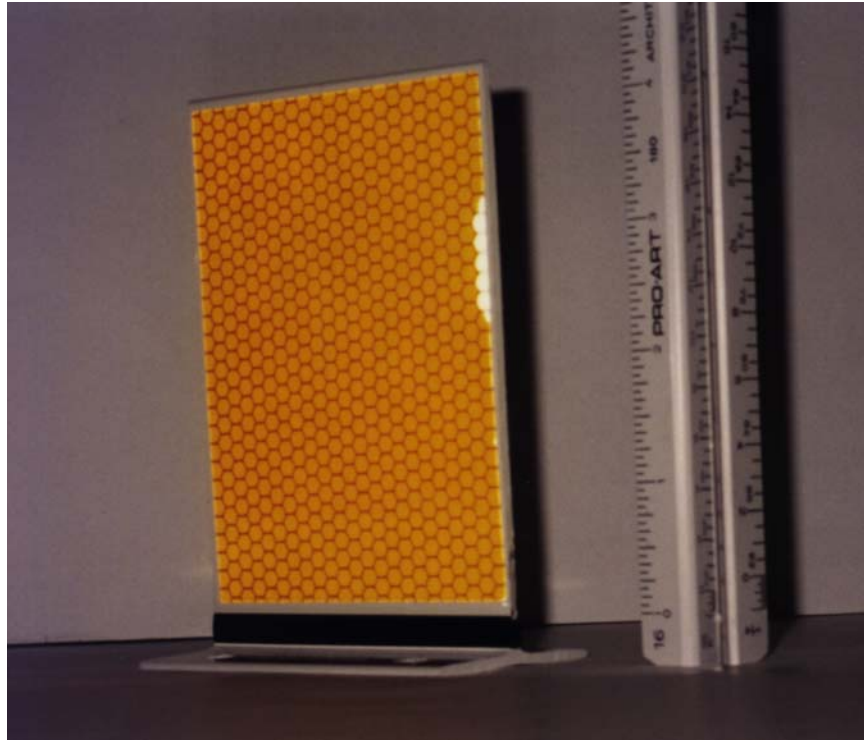
**Flexx 2020**

The Flexx 2020 is manufactured by the Duraflex Corporation. This product is a white T-shaped plastic delineator with a flexible hinge. The reflector has a dimension of 3"x4". An install time of two minutes each was recorded and this product was anchored with two 1" shot driven pin nails. Flexx 2020 delineators cost \$2.75 per delineator. Thirty-three replicates were installed starting at mile post 116.5 and 118. A picture of the Flexx 2020 is shown below.

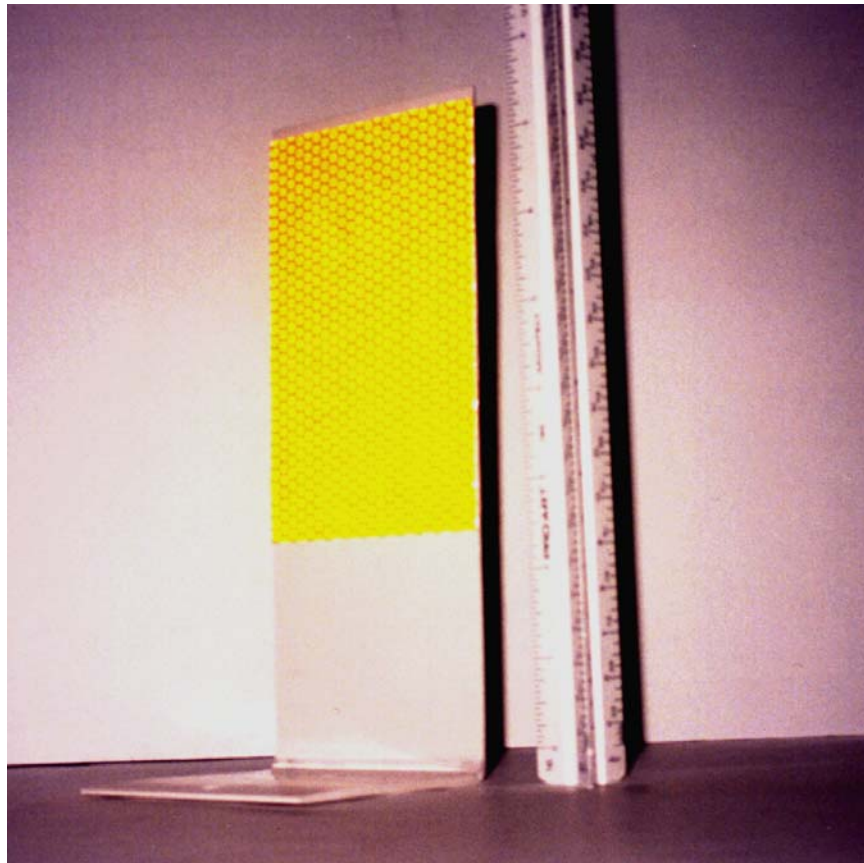
**PCBM-15**

This is the product that is currently being used by UDOT. The PCBM-15 is the larger version of the PCBM-12 and is also manufactured by Davidson Plastics. This has a possible reflector area of 3"x8". Each delineator costs \$2.35 and twenty-nine replicates were installed. PCBM-15's were installed by using two 1" shot driven pin nails. An install time of two minutes each was recorded. These were installed at mile post 118 on the on-ramp. The PCBM-15 is shown in the picture below.

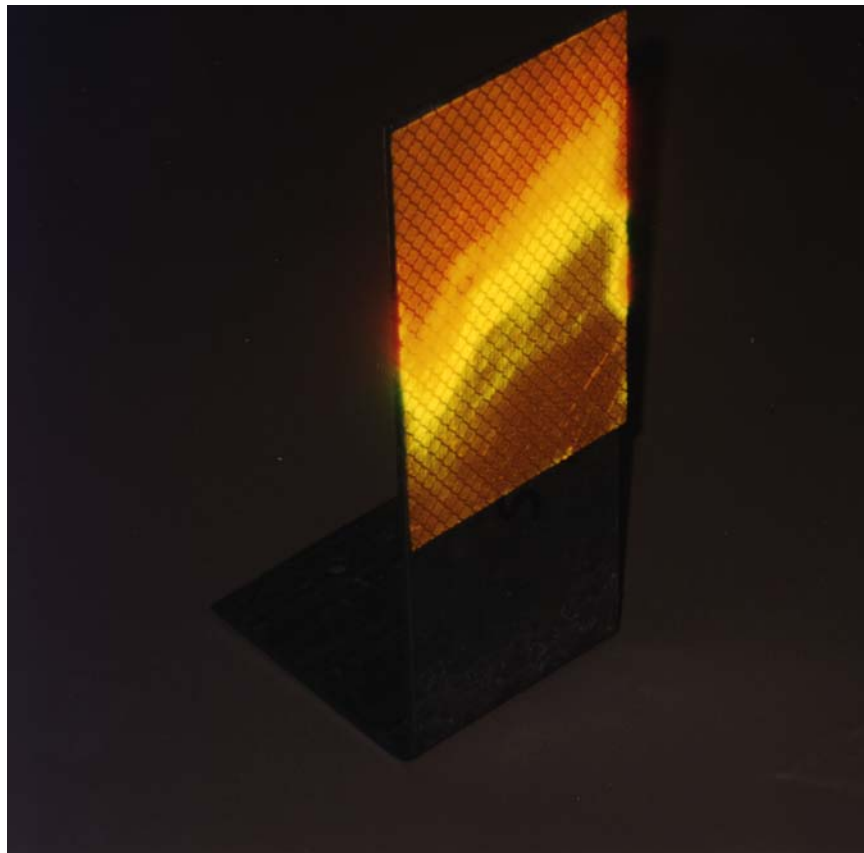
**Syro Steel Galvanized Delineator**

Galvanized Steel delineators use the same design as the PCBM-15 plastic delineator. They are manufactured by Syro Steel Company and cost a \$4.40 each. Thirty-five replicates were installed starting at mile marker 119 with an install time of two minutes each. Anchorage was obtained using two 1" shot driven pin nails. A picture of the galvanized steel delineator, manufactured by Syro Steel, is shown below.

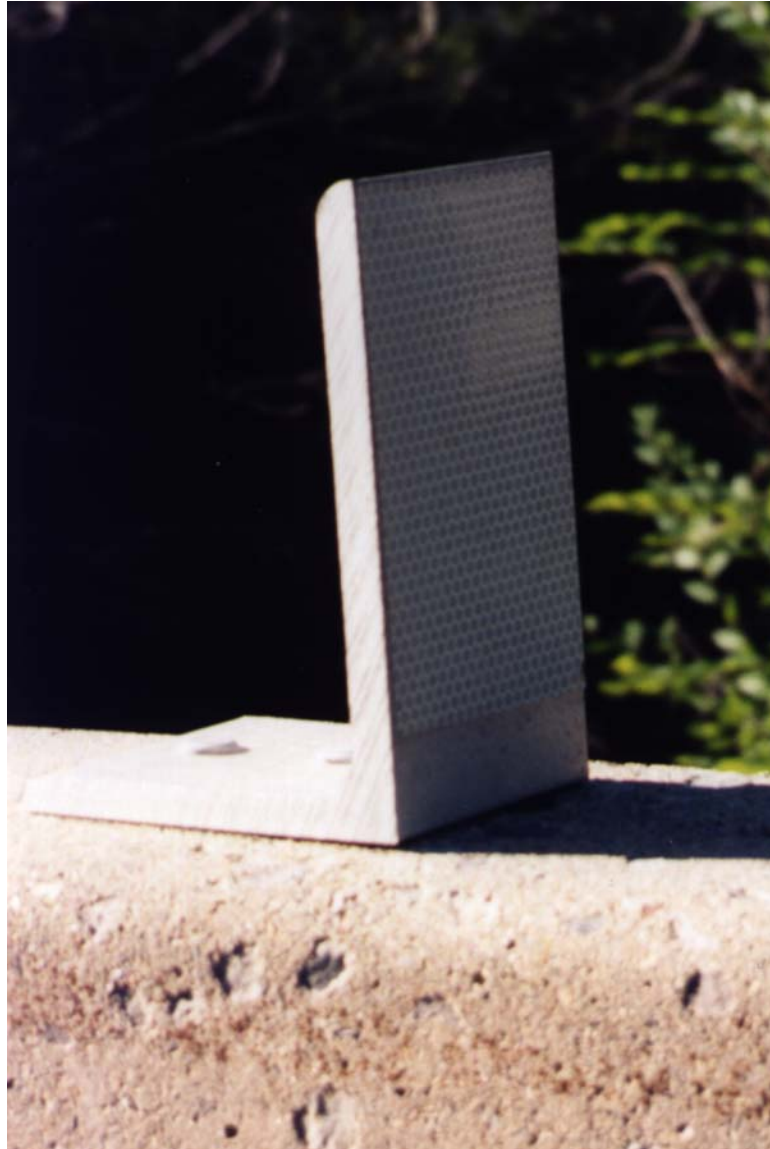
**Extruded Aluminium Delineator**

This is an extruded aluminum L-angle that is 3/8" thick. It is a product of Flasher Barricade and has a reflective surface of 3"x6". An installation time of one minute was recorded and twenty-nine replicates were installed. They were anchored using two 1.25" steel nail drive anchors and were installed at the location of mile post 119.5. This delineator cost \$3.50 per unit. An extruded aluminum delineator is shown below.

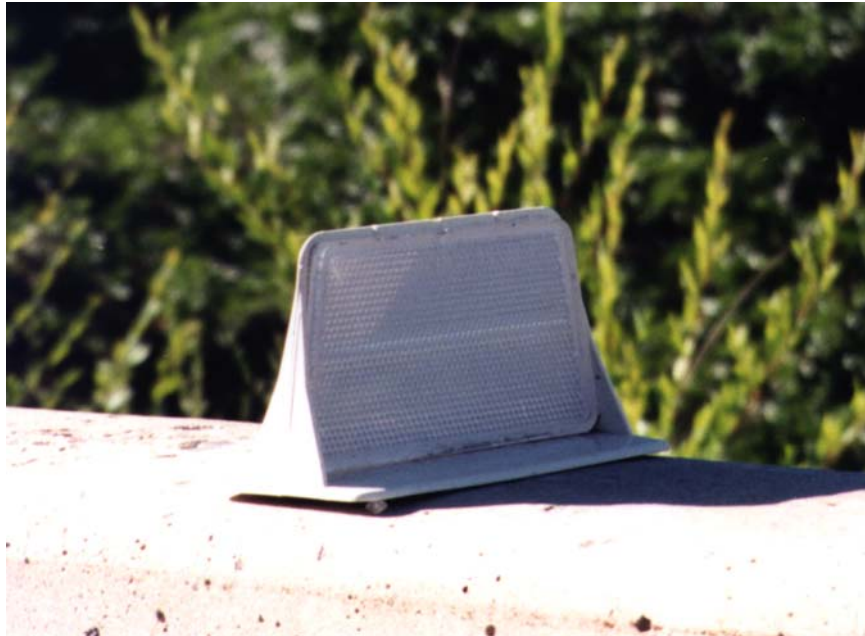
**JD-1**

The JD-1 is manufactured by Astro Optics and costs \$3.65 per unit. These delineators consist of a T-shaped stiff plastic with a 5"x3" prismatic reflector. They were attached to the concrete barriers using a Carbolite adhesive. The barriers were cleaned with paint thinner and a brass wire brush. An installation time of one minute was recorded and twenty-nine were installed at mile marker 120. Astro Optics' JD-1 is pictured below.

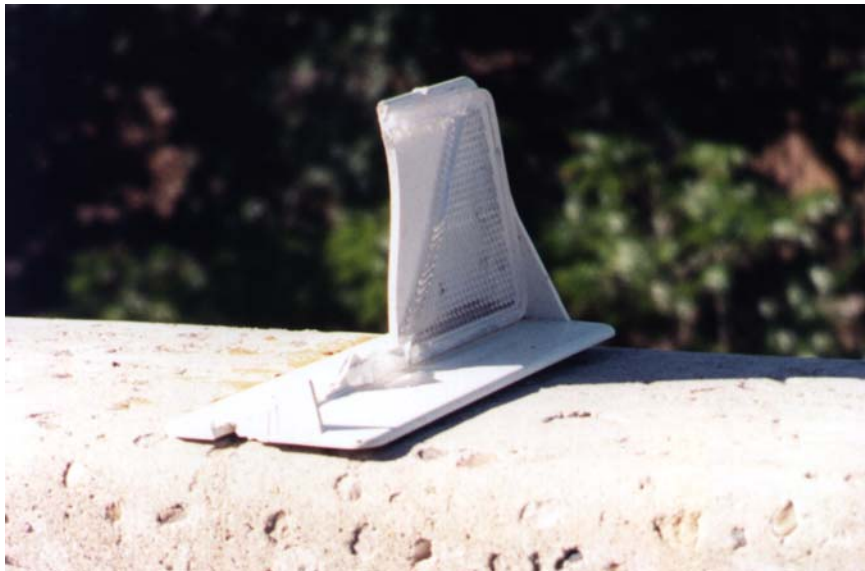
Galvanized Steel delineators, manufactured by Syro Steel, performed very poorly and also had the greatest cost. This delineator would not be a good choice due to the fact that they are expensive and they have permanent deformation from impacting snow. Figure 1 of Appendix B shows a typical example of this. These delineators also had the highest mortality rate. A reason attributed to this is that since they are one of the stiffer delineators they can tend to pry the anchors out of the concrete when impacted. Astro Optics JD-1 also did not perform very well. The adhesive used seem to work very well but the delineator itself cannot withstand an impact. This low impact resistance is illustrated in Figure 2 of Appendix B. Most of the missing delineators were sheared at the base. The JD-1 had excellent retroreflectance but it also was too short and would be covered by snow.

**Figure 2-**

**Broken JD-**

**1**

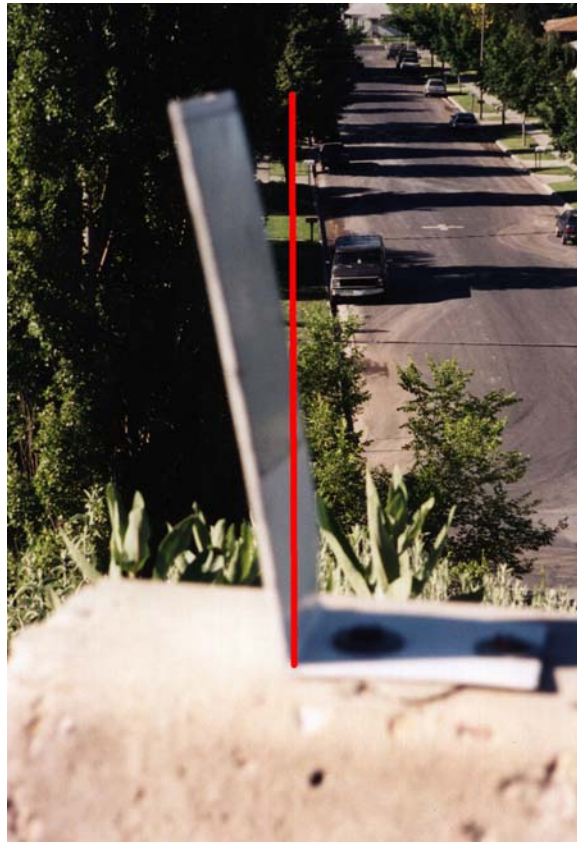
The PCBM delineators are also not the best choices. PCBM-12 performed well but they will also be covered by snow during the winter months. PCBM-15 is the current barrier delineator being used and this is not performing as well as the department would like them to perform. These barrier delineators tend to break at the 90 degree bend and they also tend to have permanent backward deformation. A typical PCBM-15, which has become bent backward is shown in Figure 3 of Appendix B. A 5/16" radius bead has been applied at the 90 degree bend to help improve the earlier versions of the PCBM-15 but they still do not perform as well as other barrier delineators.

**Figure 3- Bent**

**PCBM-15**

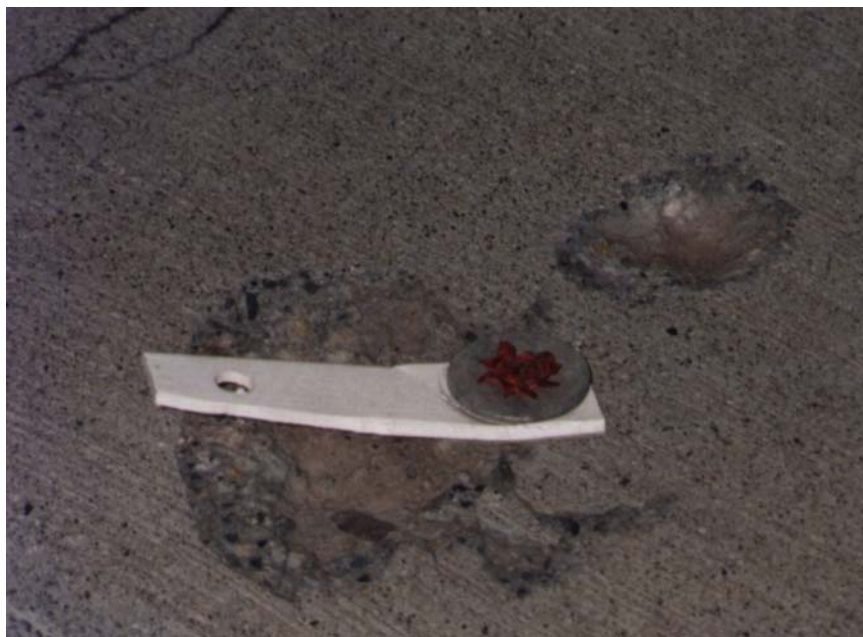
The Flexx 2020 delineators performed very well and would be a good alternative to the current delineator. These delineators are very flexible and can withstand the impact of the snow pushed aside from the snow plows. Two out of thirty-three were damaged or missing. Figure 4 of Appendix B pictures the only broken Flexx 2020 recorded. One out of the two that were damaged or missing was due was due to poor anchoring. Flexx 2020's Flex-hinge was still flexible and did not seem to be cracking or deteriorating. Literature for the Flexx 2020 is located in Appendix C. Flasher Barricade's extruded aluminum barrier delineator is the most durable delineator tested. This delineator costs

**Figure 4- Broken Flexx 2020**

The goal for this project was to find a more durable cost-effective top-mounting barrier delineator. From this field performance study, two different barrier delineators are recommended. The first is the Flexx 2020. *The Flexx 2020 barrier delineator is recommended to be used for temporary barrier.* Flexx 2020 barrier delineators are very flexible and are cost effective. *Flexx 2020's can also be used as a side-mounted barrier delineator.* Since side-mounted barrier delineators take more abuse, the very flexible Flexx 2020 would be ideal. *For permanent barriers, such as bridge parapets and guard rails, the very durable extruded aluminum barrier delineator is recommended.* These delineators are not effected by the impact of snow removal operations and are very strong barrier delineators. They cost approximately a dollar more per delineator than the current barrier delineator but with reduced maintenance costs, the life cycle value is more cost effective.
